July 03, 2013

**PRESS RELEASE**

## **Historic Zagreb Cathedral Restored with Cortec®!**

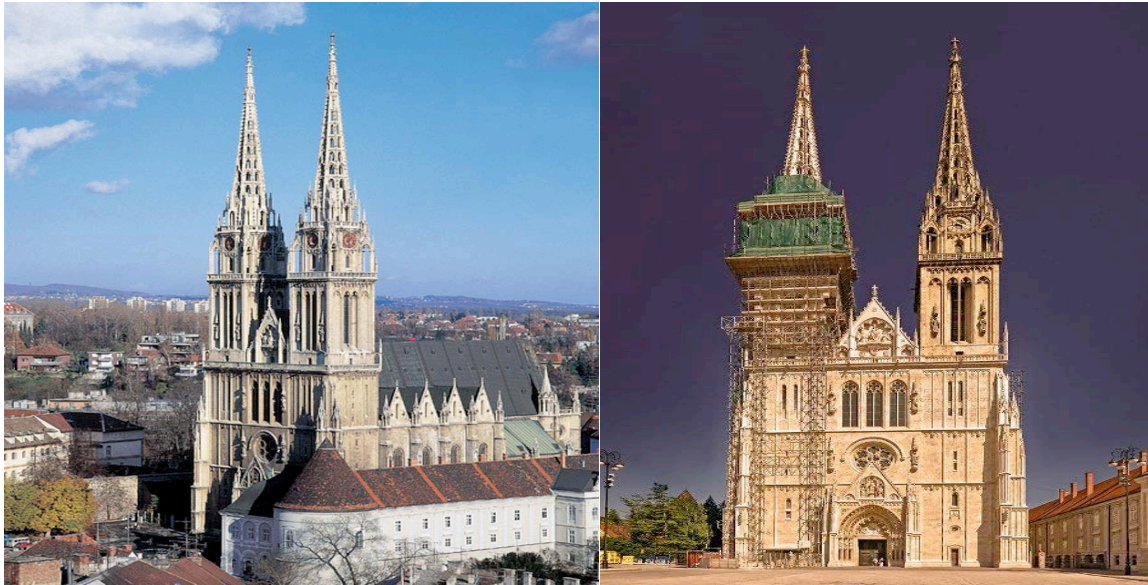
**Famous neo-gothic towers of Zagreb Cathedral restored using Cortec's CorrVerter®**

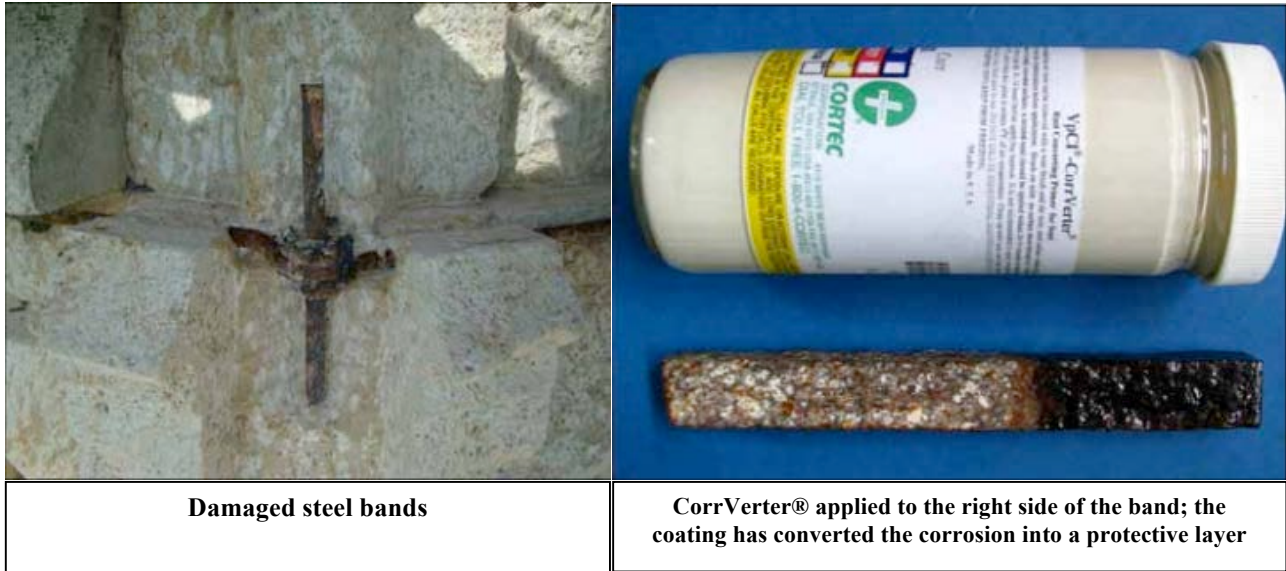
During reconstruction work on the south tower, damaged steel bands were detected surrounding the tower approximately every 3m in height. The bands were covered with rust and in drainage areas, visual damage to the diameter of the bands were present.

Economical approach with a minimum of intrusion to the structure was required to fix the condition of the bands. The mechanical resistance and structural stability of the tower needed to be maintained or improved. Faculty of Mechanical Engineering examined the bands and performed experiments on the steel bars. They recommended removal of loose corrosion from the bands surfaces, enhancing the bands in the areas of damage and application of Cortec's anti-corrosion protection product- CorrVerter®.

CorrVerter® is a water-based primer that quickly converts rust into a protective layer and is capable of penetrating into the depths of corroded surfaces. It contains a novel chemical chelating agent that modifies surface rust into a hydrophobic passive layer. Two-layers of CorrVerter® coating were brushed onto smaller surfaces and sprayed in larger areas directly onto the metal bands. The bands were then reinforced with steel fishplates that were welded on the bands and also protected with CorrVerter®.

With the help of a skilled team and good project management the entire project was completed successfully with minimal cost or intrusion as specified. CorrVerter® coating penetrated to the non- corroded part of the metal and stopped further advancement of the corrosion process.
